**SUMMARY**  
1234 Main Street Kemptville ON K0G  
1J0  
Buyer Name  
2025/06/08 9:00AM

Noel McCleery  
Home Inspector  
Irongate Inspections  
6132525626  
noel@iginspections.ca

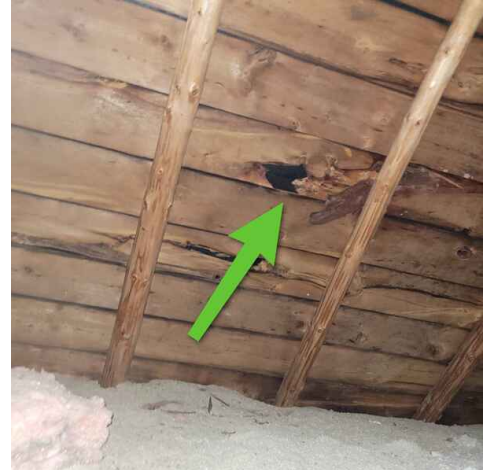
#### 2.4.1 Roof Structure & Attic **THIN/SOFT SHEATHING**

Description: Roof sheathing appears to be soft/thin in certain areas. This can be from decay in the underlying wood panels & structure.

Implications: Further damage if the roof shingles fail.

Recommendation: Further examination by a qualified. roofer.

Contact a qualified roofing professional.

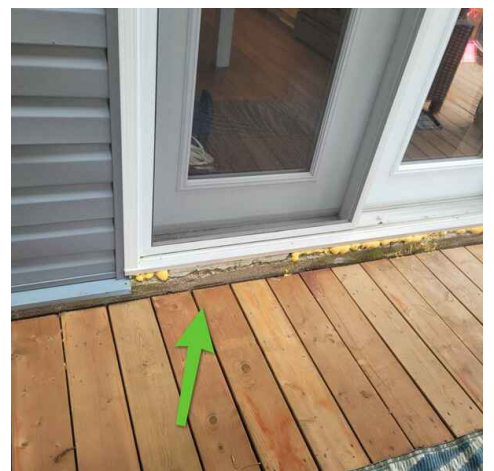
#### 3.2.2 Exterior Doors **PATIO DOOR - MISSING FLASHING**

Description: The rear patio door is missing flashing.

Implications: Inadequate water protection, may lead to water damage, intrusion, rot.

Recommendation: Remove excess spray foam, install flashing to terminate below the deck.

Contact a qualified professional.

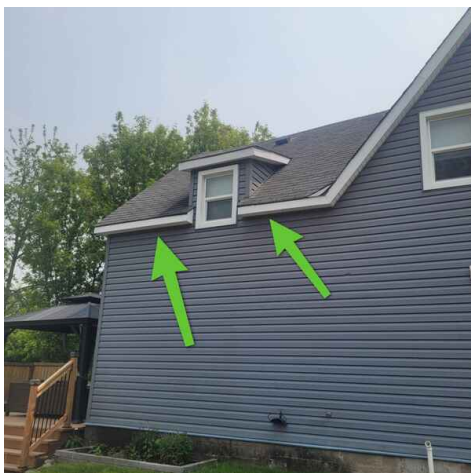
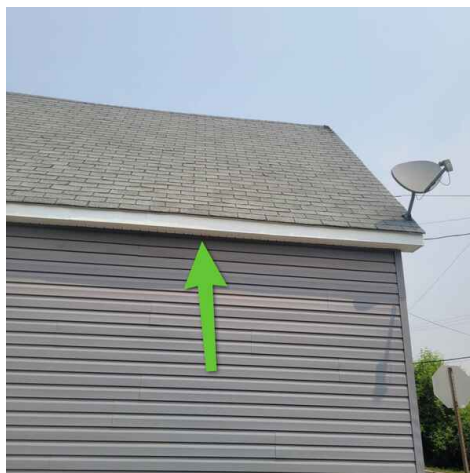
#### EAVESTROUGHS MISSING

Description: Eavestroughs and downspouts are missing in one or more areas.

Implications: Water will run off the roof and pool around the foundation. It will also erode the soil or gravel around the home.

Recommendation: Install new eavestroughs and downspouts where they see missing.

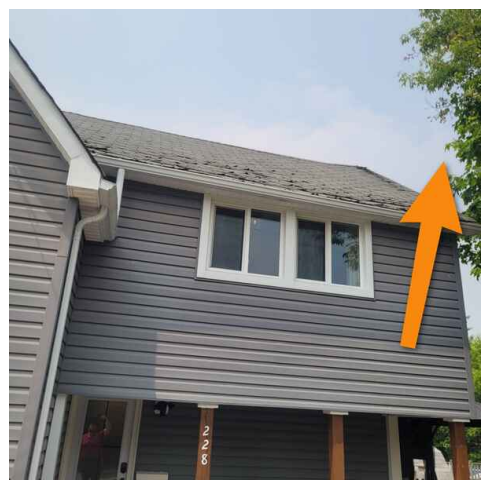
### TREE OVERHANG

Description: Trees observed overhanging the roof.

Implication: This can cause damage to the roof and prevent proper drainage.

Recommendation: A qualified tree service trim to keep foliage away from the roof and gutters.

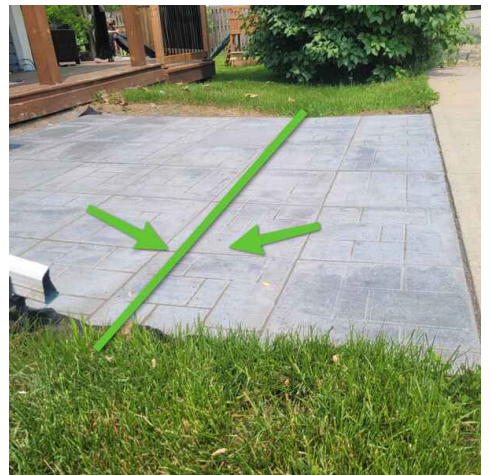
#### PATIO - IMPROPER SLOPE

Description: The patio stones have improper slope.

Implications: Water pooling, ice damage potential.

Recommendation: Remove and fix base, slope patio pavers correctly.

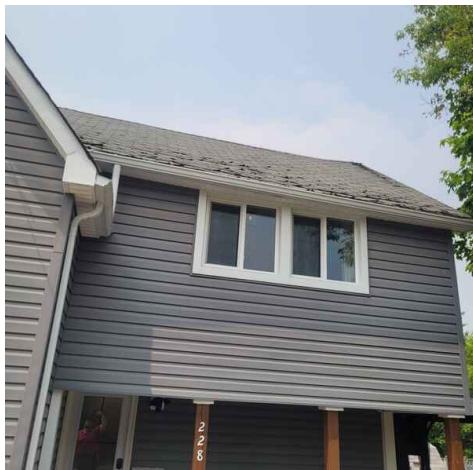
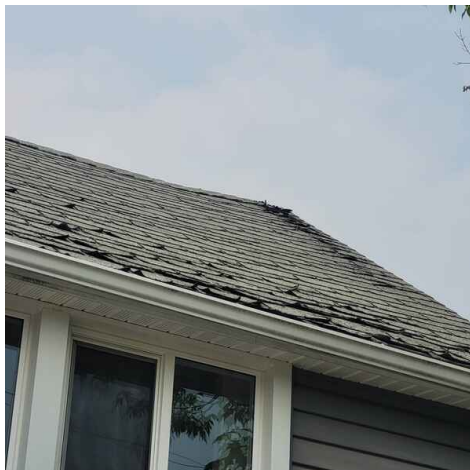
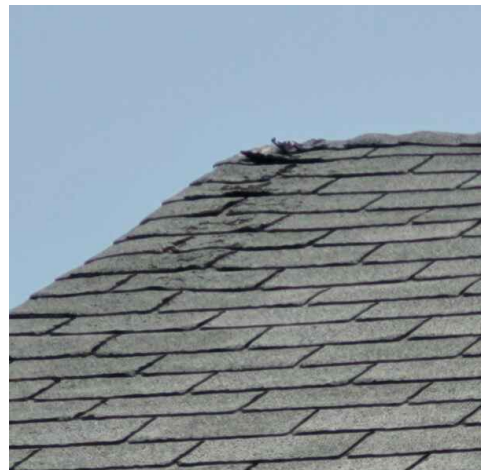
#### DAMAGED COVERINGS

Description: The roof coverings exhibited general damage that may or may not currently be could affect performance or leaking.

Implications: The roof may leak and cause damage inside the attic, or the house.

Recommendation: Contact a qualified roofer evaluate, make recommendations and repair.

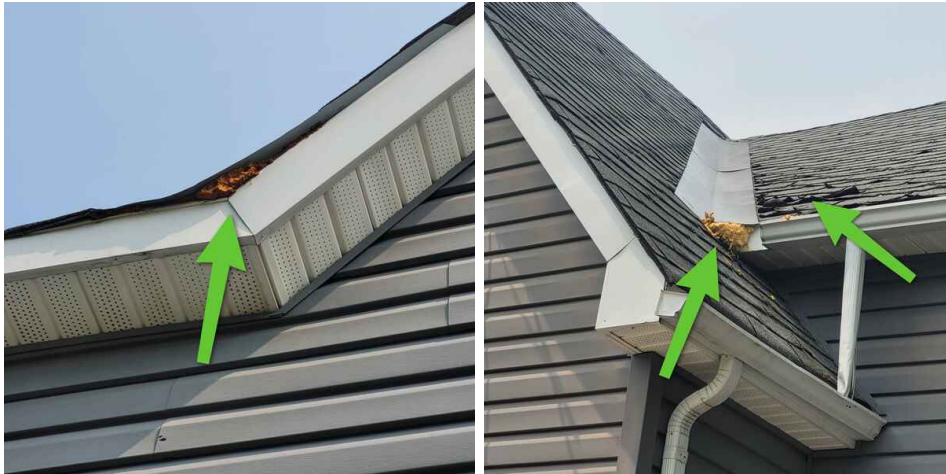
### SUSPECTED LEAK

#### VALLEY FLASHING (2 PLACES)

Description: Evidence of possible leaks were observed in the form of damage shingles, spray foam, general poor roof covering conditions.

Implications: Roof leaking, causing damage to other components in the home. Possible introduction to mold in the attic or behind the walls.

Recommendation: Contact a qualified roofer evaluate and repair.

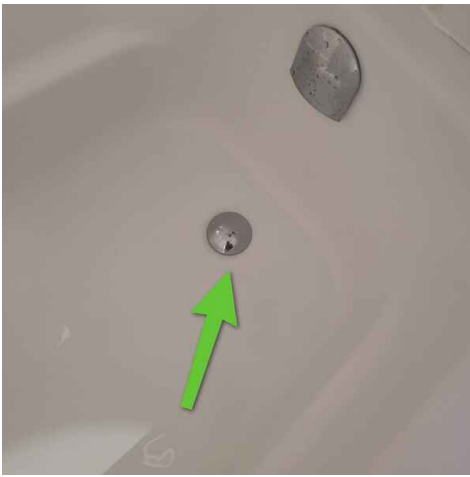
Main bathroom drain plug.

Tub plug doesn't work

Recommendation: Repair and replace as necessary.

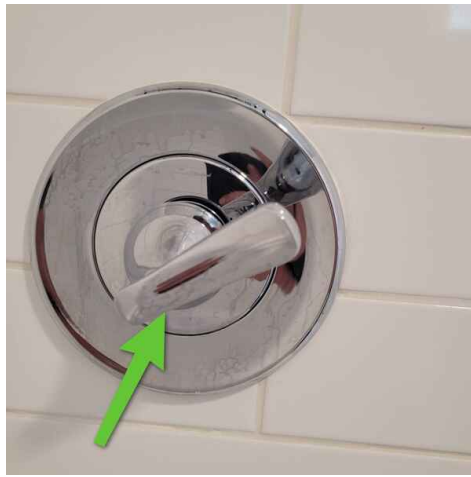
Main bathroom shower handle (loose).

Loose Handle

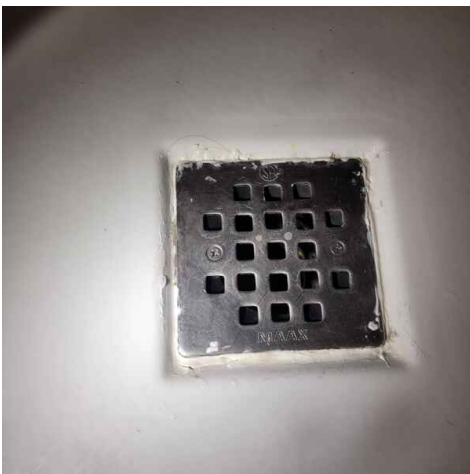
Description: Caulking missing, incomplete or deteriorated in the bathroom(s).

Remove cover and reinstall correctly

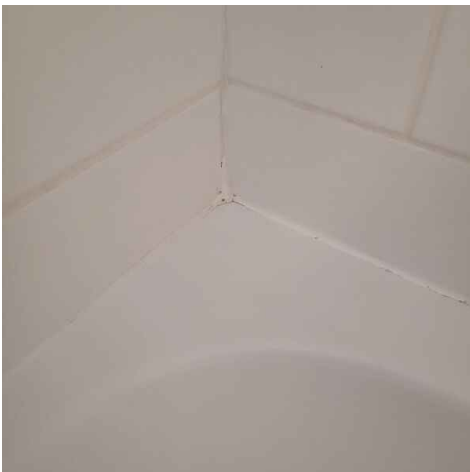
Implications: Water intrusion behind the wall, causing damage, rot and or mold.

Corner silicone missing

Recommendation: Repair caulking.

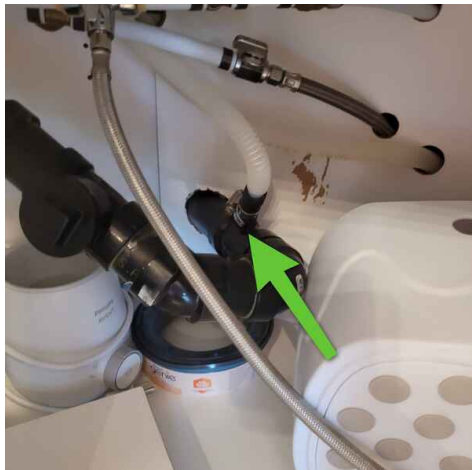
**DRAIN INSTALLED "BEHIND TRAP"**

Description: The dishwasher drain is installed "behind the trap" meaning there is no gas trap proceeding the dishwasher drain connection.

Implications: Possible sewer gasses climbing back into the dishwasher.

No P-Trap Following Dishwasher Drain

Recommendation: Repair as necessary, seek consultation from licensed plumber if required.

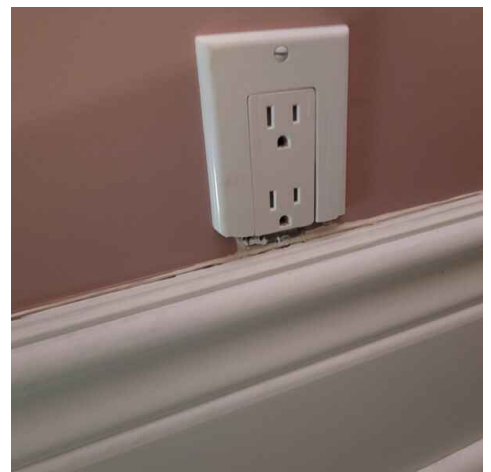
### COVER PLATES DAMAGED

Description: Pink bedroom receptacle has a damaged cover plate.

Implications: Safety issue, shock hazard

Recommendation: Repair/replace

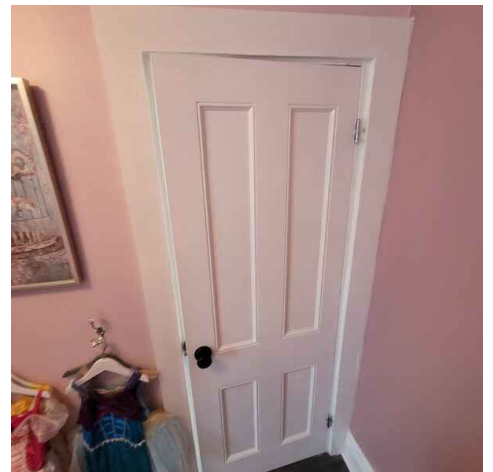
### DOOR DOESN'T CLOSE

PINK BEDROOM

Description: The door to the pink bedroom does not shut. It is binding on the hinges.

Implications: Lack of privacy, small children able to leave bedroom unsafely.

Recommendation: Adjust the door to close properly.

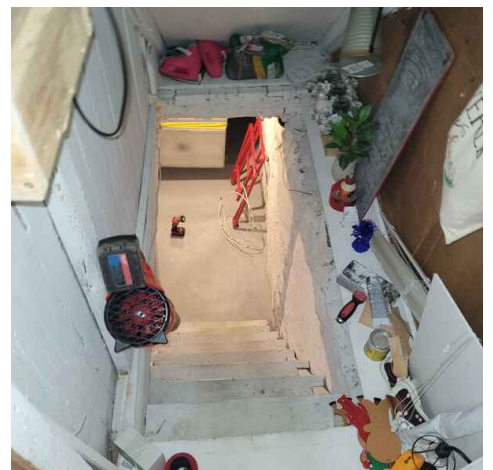
### UNSAFE STAIRS

BASEMENT STAIRWELL

Description: The basement stairs are unsafe.

Implications: Trip Hazard.

Recommendation: Add handrails and more lighting. Declutter stairwell area.

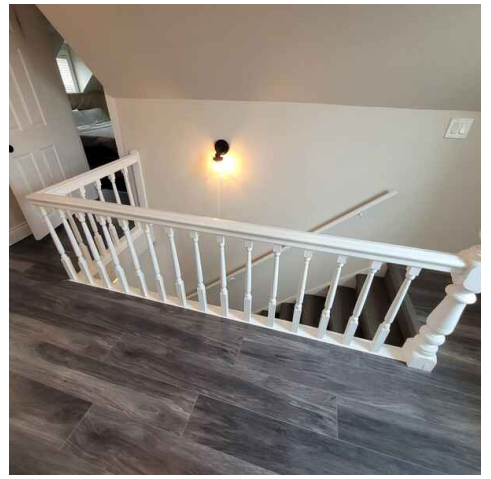
#### HANDRAIL - TOO LOW

Description: The upstairs landing handrail is too low and loose.

Implications: The railing will not reasonably stop somebody from falling down the stairs.

Recommendation: Replace the handrail with a more secure, taller handrail.

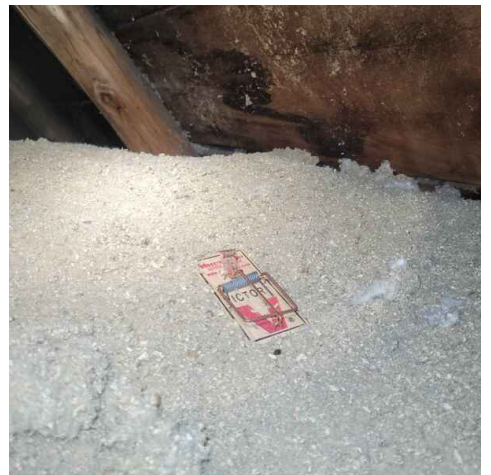
#### EVIDENCE OF RODENTS

Description: Evidence of rodents apparent in the attic. Mouse traps and tunnels were observed.

Implications: Potential damage to electrical wiring and insulation. Health concerns, diseases, allergies, asthma.

Recommendation: Monitor the mouse traps, add more as needed. If the problem persists seek help from a pest exterminator.

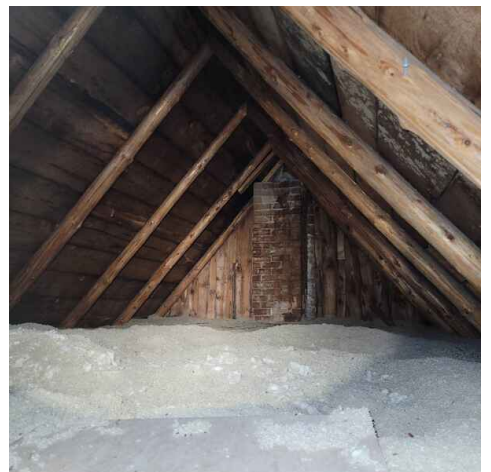
#### ATTIC VENTILATION INSUFFICIENT

Description: The attic venting was insufficient at time of inspection. The space was hot, humid, stale and not breathing.

Implications: Possible condensation, mold, loss of efficiency, damage to wooden structural members.

Recommendation: Add gable ventilation. Consult with attic contractor or roofing contractor.

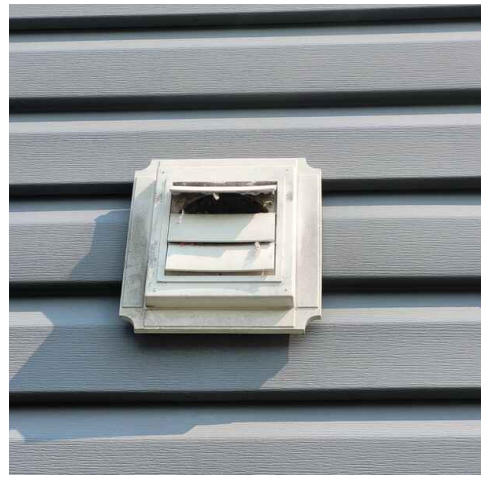
#### DRYER VENT - BROKEN/CLOGGED

Description: The dryer vent exterior cap appeared to be broken and clogged.

Implications: Possible fire hazard, reduced dryer efficiency, possible condensation in duct causing rust and or damage to the dryer.

Recommendation: Replace the exterior cap, ensure to silicone the outside of the new one.
